ENCLOSURE B (CONT'D)

LEGEND

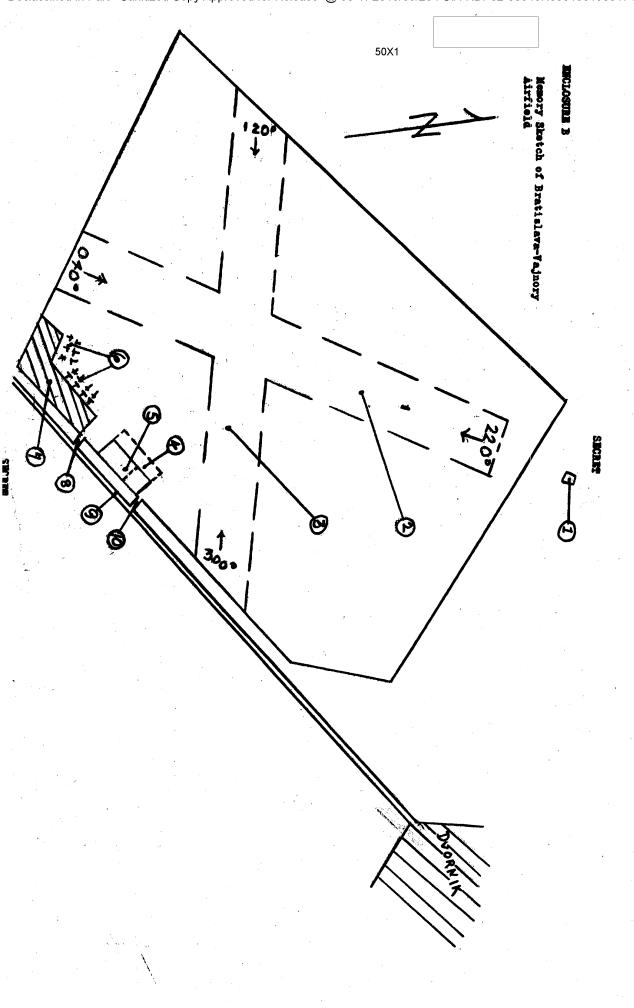
- Point #1. DF Station: five by five by four meters; brick building, flat roof with single loop, direction-finding antennae.
 - 2. Runway #22: 040° /220°, 1050 x 60 m., level and hard grass surface, in good condition. This runway had unlimited possibilities for extension toward the northeast only. The major Bratislava freight yards were located one quarter kilometer south of the southwest end of this runway.

- 3. Runway #12: 120°/300°; 950 x 60 m.; level and hard grass surface, in good condition. This runway could be extended one half to three quarters of a kilometer to the west only. The town of Dvornik was adjacent to the east end of this runway.

- 4. Concrete Apron: 45 x 10 m., in good condition. (The field had no taxi-strips or perimeter tracks.)
 - 5. Hangar and Administration Building: 45 x 20-25 x 10-12 m., stucco brick construction. The northeast third of the building housed the administrative offices, which in Summer 1950 included meteorological office, radio room, and briefing room; this part of the building had a flat roof. The remaining two-thirds of the building was a hangar with a shed roof; in Summer 1950 observed three or four small, civilian planes and two CSA DC-3 type aircraft in it. (There were no hardstands or revetments at this field.)

- 6. Fifteen Arado Advanced Trainers: were observed in this location when flew over this airfield in March 1953 while making a landing approach for Bratislava-Ivanka airfield. (Arado aircraft were the advanced trainers of the Czechoslovak Air Force.)

- 7. Bombed Hangars: the ruins of several heavily damaged hangars were evident here.
 - 8. Military Entrance: used exclusively by Air Force personnel in 1950.

- 9. Bratislava-Dvornik Highway: six meters wide; concrete surface, in good condition.
 - 10. Civilian Entrance: led from the highway (Pt. 9) to the Administration Building and Hangar (Pt. 5).
